INVENTORY AND SCHEDULE OF CONDITION

Property Address: 1 Any Street

Carried Out: 29th February 2021

Sheridan Inventory Services Reference: 1X9989

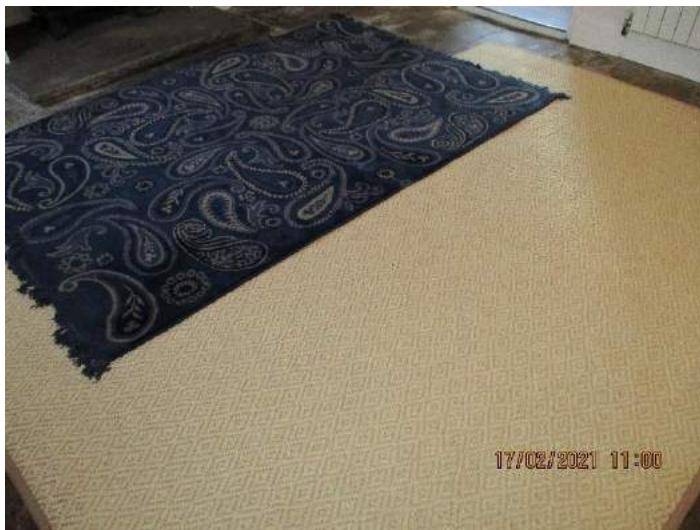
L8	Stone flagged floor	Marked in accordance with age of property Unable to fully inspect due to rugs/mats	
L9	Blue paisley patterned rug with tasselled ends	Some marks and wear Spillage stains towards centre of one long edge	
L10	Gold coloured diamond patterned rug with brown fabric perimeter	Some marks and general wear	
L11	Lace curtain on rod above door transom		
L12	Plastic curtain track above door		
L13	Red spotted lined curtain with rope tieback sash	Some marks	
L14	3 x unpainted shelves on Dexion brackets		
L15	Double socket		
L16	2 piece white finished wooden framed window White painted sill cap	Some flaking and peeling to paint finish on sill cap and frame	
L17	White lace curtain affixed to rod		
L18	Plastic curtain track on white painted batten		
L19	2 x red spotted lined curtains	Some marks Slight damage to lining material	
L20	Aerial cords through window frame		
L21	3 x unpainted pine shelves of different dimensions

Rugs

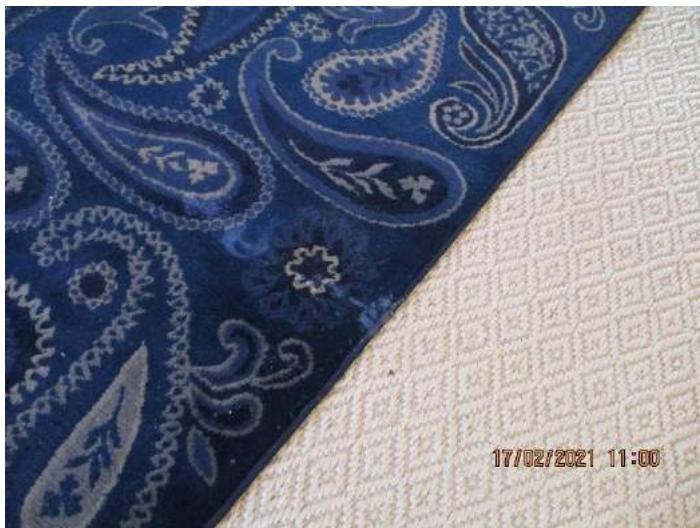
Stain on Paisley patterned rug

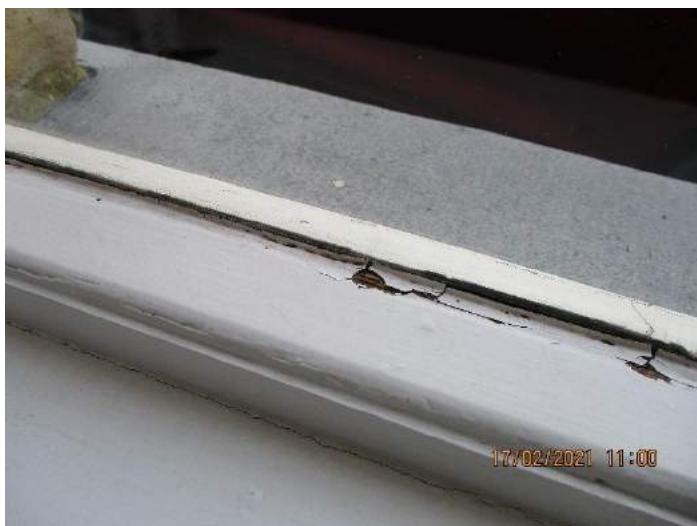
Window frame paint finish

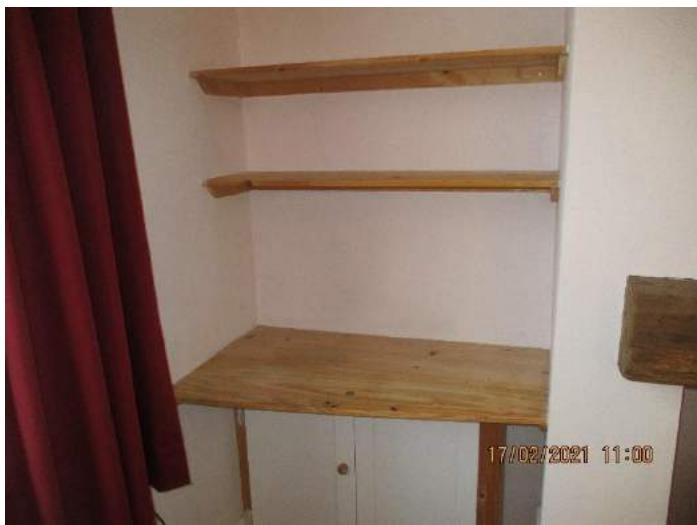
L22	Low level cupboard 2 x white painted doors Contains electricity meter and fuse panel with hinged flap	Knob on left door only Doors foul on shelf above	
L23	Double socket		
L24	Inset oak lintel	Marked in accordance with provenance	
L25	Slab fire base	Marked in accordance with provenance Front edge chipped and damaged

Shelves and electrical cabinet

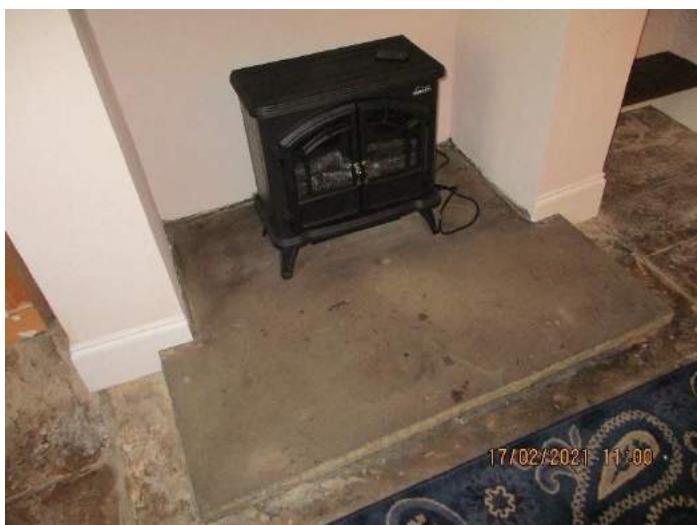
Fire and base

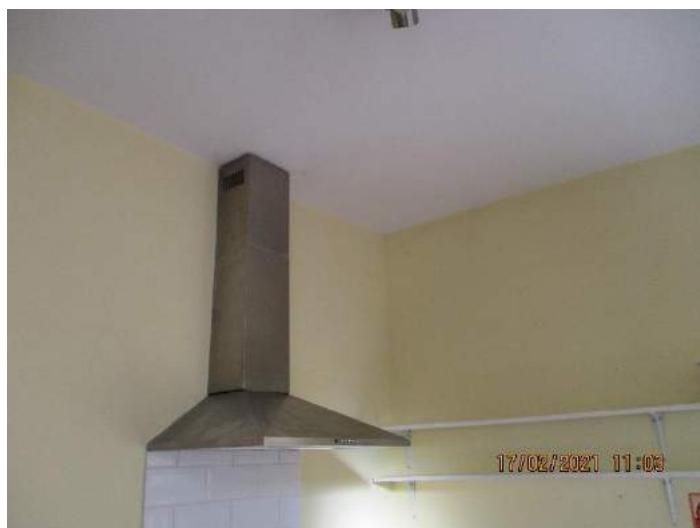
KITCHEN			
REF	FEATURE	COMMENTS	TENANTS COMMENTS/ CHECKOUT
K1	White ceiling	No evidence of excessive or uncontrolled condensation Slight discolouration around perimeters and adjacent to extractor chimney	
K2	Circular metal light fitting with 3 x adjustable spotlights		
K3	Primrose painted walls	Old defects and irregularities in line with age and nature of property Some pins and hooks Finish slightly flaking and peeling behind living room door Fitting removed behind living room door Slight scuffs and marks	
K4	Laminated floor with partial beading	Some scratches, indentations and drag marks Faint paint splash marks Beading discontinued facing	
K5	Light switch

Ceiling around extractor chimney

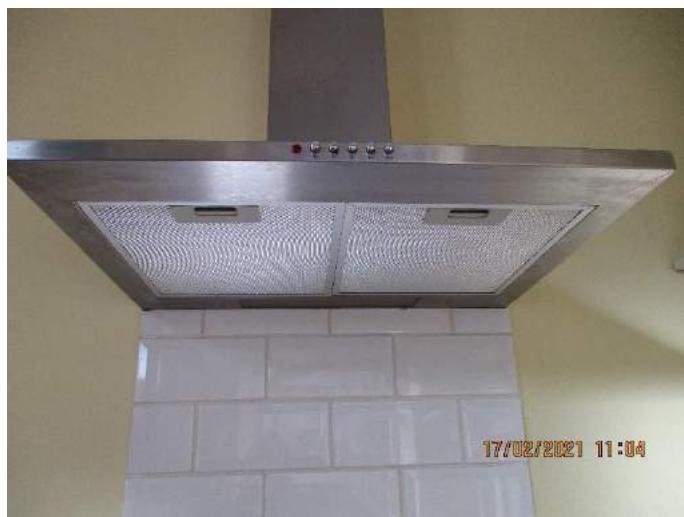
K6	Extractor hood	Slight marks around casing and intakes	
K7	Cooker/ isolator switch		
K8	Double socket		
K9	<i>ALL UNITS WHITE VENEERED FASCIAS WITH METAL ROD HANDLES</i> <i>WHITE TILED SPLASHBACKS</i> <i>WOODBLOCK WORKTOPS</i>	Splashbacks to left only Some discolouration to tile fixative Marks and wear to worktop stain Some water damage to worktops around sink – would benefit from preservative treatment	
K10	1 door 2 shelf cupboard lower left		
K11	Free standing New World electric stove 4 burner ceramic induction hob Grill section with shelf Oven section with 2 x shelves	Some wear and discolouration to burners and perimeters Superficial scratches to hob glazing Some burned on grease and carbon deposits in grill and oven base and sides Superficial corrosion to shelf supports Cleaned within limitations of age and previous use	
K12	Currys dishwasher with plastic cutlery tub	Some signs of use	
K13	3 x white finished shelves of varied dimensions	Some scratches, chips and marks to each

Extractor hood

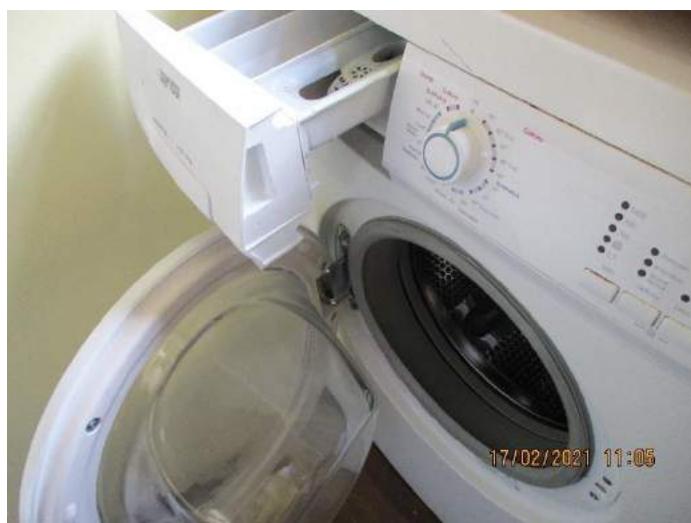
K17	Circular pressed stainless sink Chromed mixer tap	Some scratches and tarnishing Slight indentations in bowl to left	
K18	Zanussi washing machine	Marks to casing Some discolouration in soap tray and door seals	
K19	Units below sink: 2 door cupboard with stopcock, double socket and gas meter 5 x open bottle shelves	Base heavily marked No back	
K20	Wooden door and frame - green painted outer, white inner Frosted glass transom Mortise lock Upper and midpoint bolts Metal handle Double hook affixed	Some marks and old damage Lower right panel appears retro fitted	
K21	Plastic curtain track above door		
K22	Blue velvet lined curtain with rope tieback sash	Some marks	
K23	White painted architrave to under stairs area	Former door fittings removed Some marks to lower right 2 x pins to left with internal keys - labelled	
K24	Small wooden framed pen drawing of Salts Mill		
K25	Wall mounted metal wipe clean memo board

Washing machine casing, soap tray

and door seal

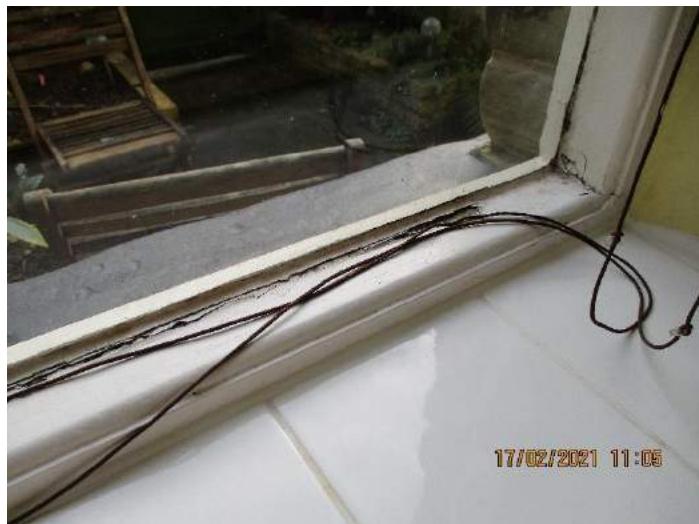
K14	2 piece white finished wooden framed window Tiled sill	Paint flaking and peeling to lower inner frame Some discolouration to tile fixative on sill cap Wall to right marked and discoloured	
K15	Plastic curtain track affixed to batten	No curtains	
K16	Wooden venetian blind with cord controls	Mechanism stiff

Lower window frame

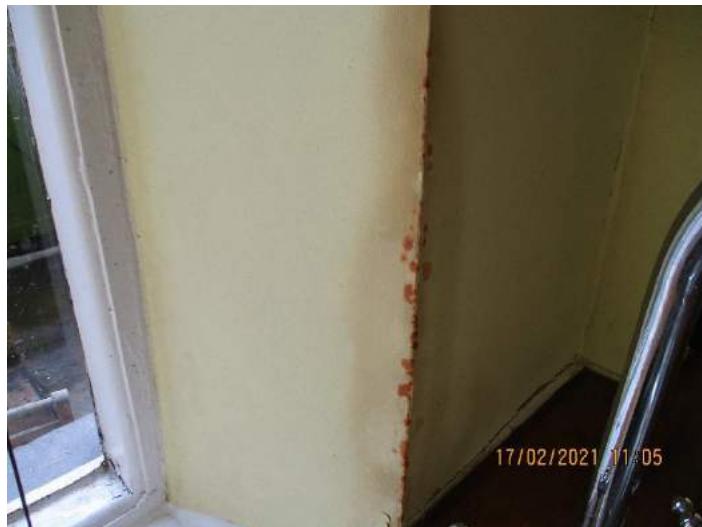
Wall to right of window

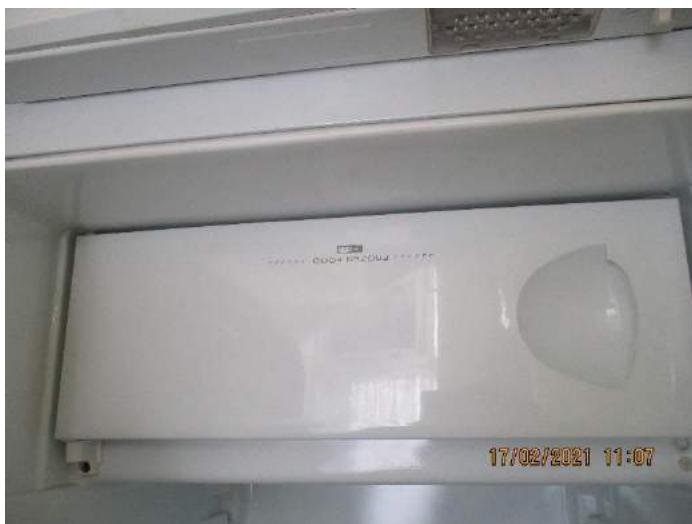
U13	Hotpoint fridge with upper icebox 1 ½ glass shelves, salad crisper, 2 door pockets	Marks and discolouration to external skin Some discolouration to internal skin Icebox door fitted upside

down Trim missing from ½ glass shelf	
U14	White painted frame around lower storage area 3 x unpainted pine shelves		
U15	White net curtain on wire over storage area		
U16	Double light switch	Right switch activates outside light	
U17	Free standing powder fire extinguisher		
U18	Brush		
U19	Mop and bucket		
U20	Metal step ladder	Heavily marked Secured to wall with extemporised wire clip	
U21	Some manuals and instructions

Fridge ice box cover

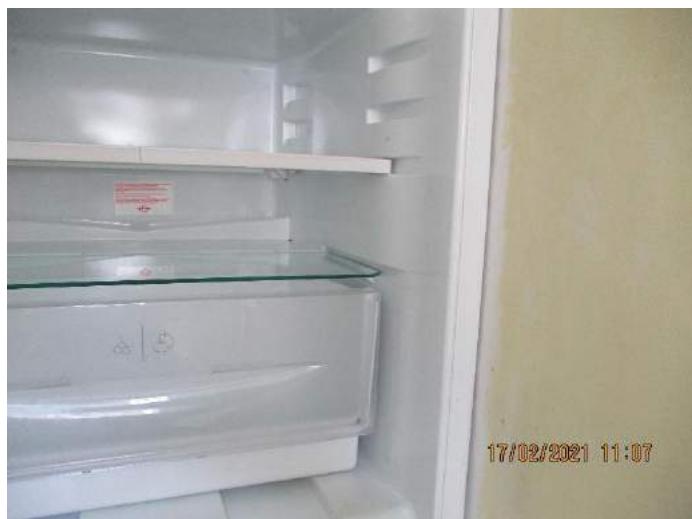
Fridge interior

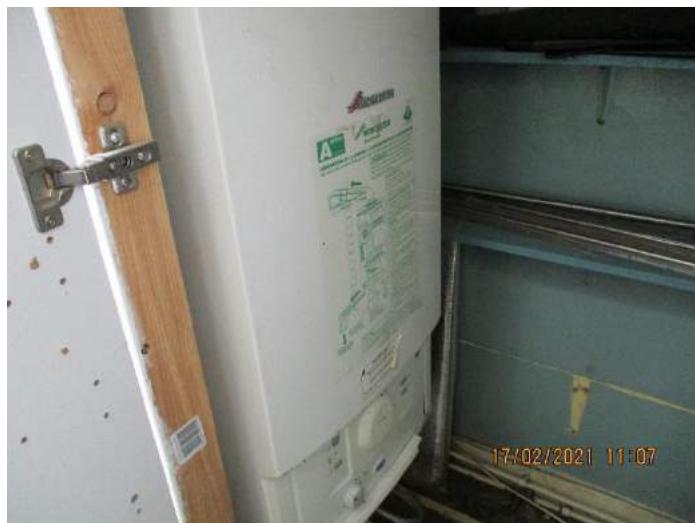
BOILER CUPBOARD		
REF	FEATURE	COMMENTS	TENANTS COMMENTS/ CHECKOUT
O1	Decor unfinished		
O2	Worcester combi boiler with controls on lower casing	Cover over controls detached	
O3	2 x blue painted shelves		
O4	Dumped loose items in base

Boiler

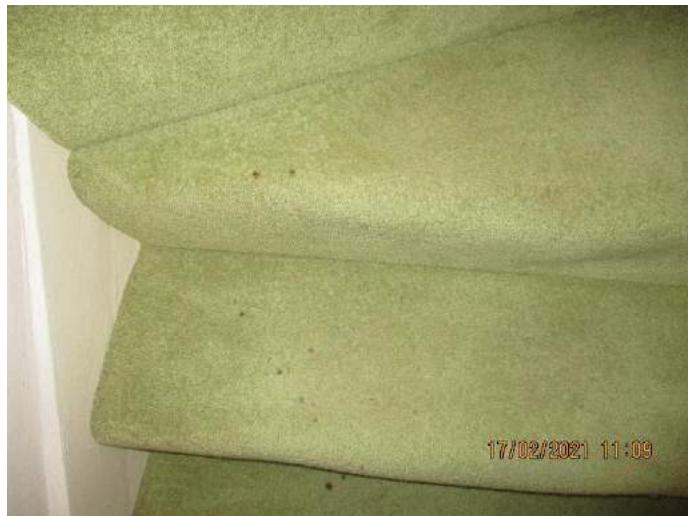
Spillage stains on stair treads

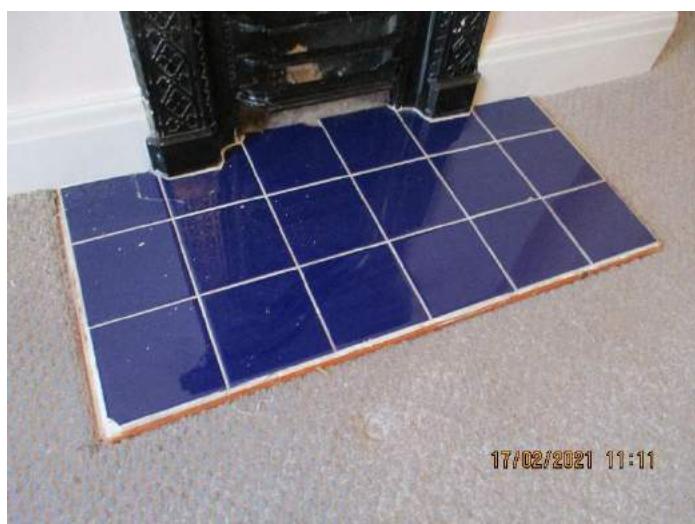
Nap worn immediately inside door Light coloured discolouration adjacent to former fireplace Unable to fully inspect due to furnishings	
B7	Light switch		
B8	Double socket		
B9	USB point		
B10	Radiator with thermostatic valve		
B11	2 piece white finished wooden framed window Partial UPVC cap on lower frame White painted sill cap	Considerable deterioration to frame, especially in right corner - wood rotting and falling away Sill cap finish flaking and peeling Evidence of standing water on sill cap	
B12	Lace curtain on wire		
B13	Plastic curtain track affixed to batten		
B14	2 x blue floral patterned curtains	Somewhat washed out and faded	
B15	2 x wood stained louvered doors to inset cupboard Knob handles Contains 3 x slatted shelves and wood stained base	Some marks to shelves Different internal finish	
B16	Single socket		
B17	Black painted metal former fire surround and mantle Blue tiled hearth	Decorative purposes only Some paint speckles to hearth Slight chips in hearth tiles left of fireplace and 2 nd from right, centre course

Former hearth

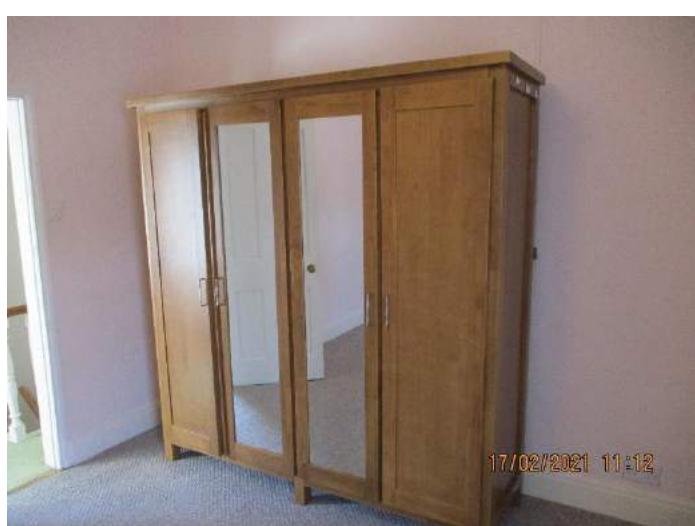
B18	Double socket inset in alcove		
B19	Oak wardrobe 4 doors with metal rod handles 2 x centres mirrored	Slight chips and scratches to finish Plastic hooks affixed to right

Wardrobe

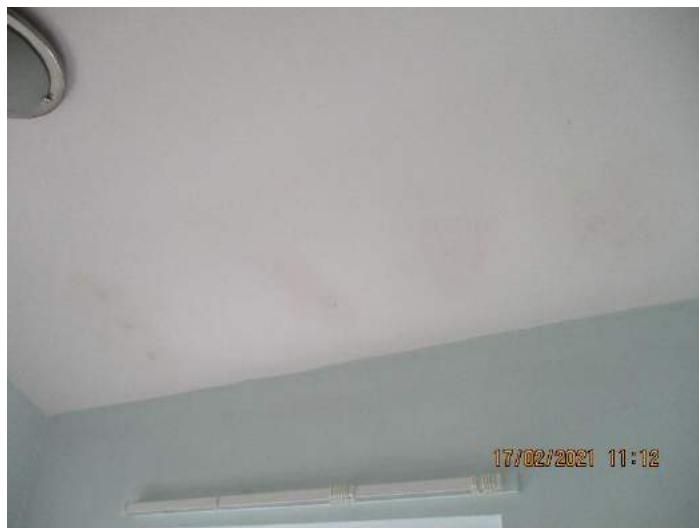
BATHROOM			
REF	FEATURE	COMMENTS	TENANTS COMMENTS/ CHECKOUT
A1	White partially angled ceiling	No evidence of excessive or uncontrolled condensation Patch repairs above window	
A2	Circular translucent light fitting with metal frame	Low output bulb fitted at time of inspection Some detritus in shade	
A3	Ceiling rose and light pull cord		
A4	Ceiling rose and shower pull cord		
A5	Pale blue painted upper walls Cream tiled with patterned horizontal bands around bath and to lower	Some old defects and irregularities evident in painted walls in line with age and nature of property Some picture hooks in painted walls Some discolouration to tile fixative especially in shower area	
A6	White woodwork and skirting		
A7	Wood stained board floor	Some chips, scratches and wear to stain Indentations in places Paint speckles	
A8	Wall mounted metal towel rail	Top rail bent	
A9	Moulded resin bath White painted wooden panel Supplementary seal strip Chromed mixer tap	Seal and seal strip rough in places Marks to seal strip Paint finish on panel flaking and peeling Water damage to panel in left corner Evidence of resealing to bath rim

Ceiling finish above window

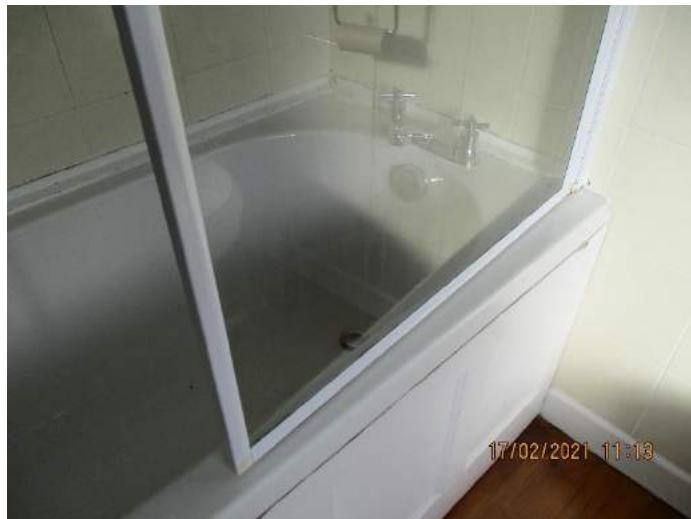
A11	White coated glazed shower screen and bracket	Lower seal strip marked and discoloured	
A12	Wall mounted toilet roll holder		
A13	White WC and cistern with single push flush White plastic seat	Coating on flush mechanism worn	
A14	White painted wooden framed 2 piece opaque glazed window White painted sill cap	Chips, scratches and old damage to sill cap Signs of deterioration to lower frame Paint finish flaking and peeling in frame	
A15	Wire for net curtain affixed to central bar	No net curtain	
A16	Plastic curtain track affixed to white finished batten	No curtains	
A17	Wooden venetian blind with cord controls		
A18	Radiator concealed behind white painted panelling with circular perforations		
A19	White painted ledge in right corner		
A20	Sink with chromed mixer tap	Some discolouration to rear seal strip	
A21	Wall mounted cup holder		
A22	Wall mounted towel hoop		
A23	Wall mounted wooden framed square mirror

Bath panel and shower screen
